University of Missouri in Columbia

02/25/2015

Jones Dorm Abatement & Demolition

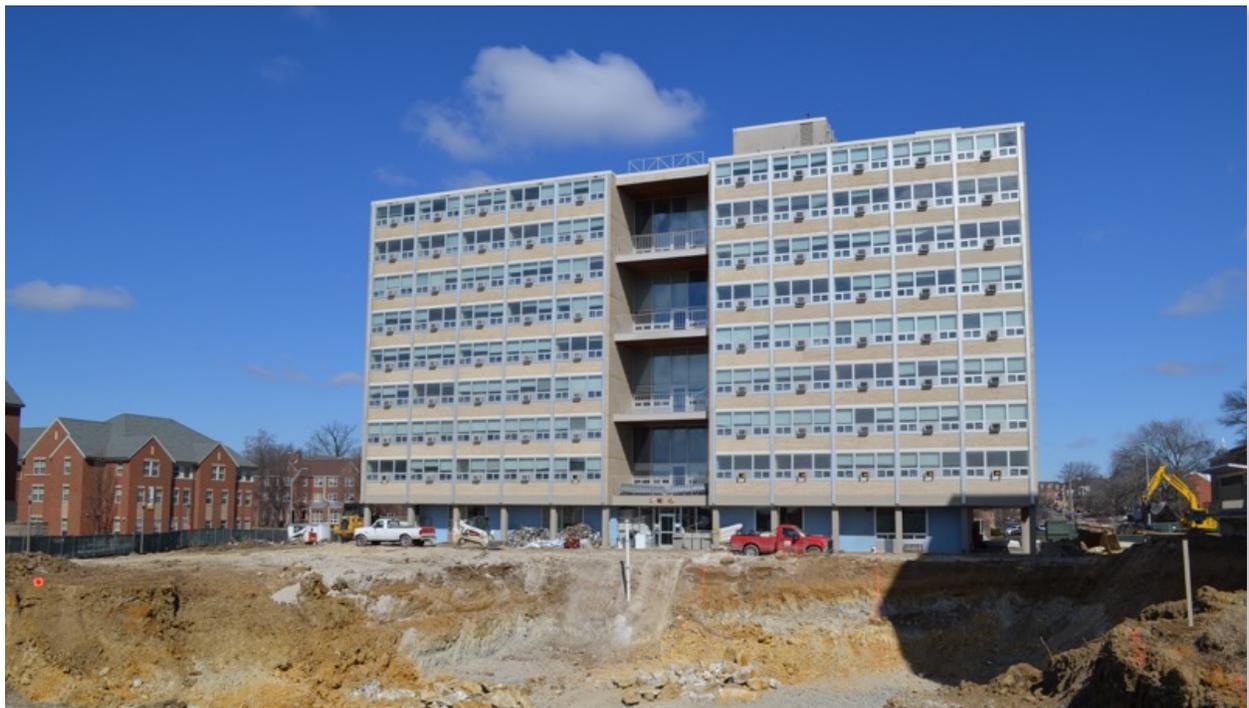
Jones dorm, pictured above, at the University of Missouri in Columbia is one such asbestos-laden facility that was still in use until this year when AT Abatement and Demolition were brought on to deconstruct the 1960s era building as part of the Dobb's group replacement phase 1. While the asbestos in the building didn't pose any particular risk to residents (though had the potential to make repairs much more dangerous), the out of date building was no longer meeting the needs of the students housed there, and university curators decided it was time to replace the facility. The building will be replaced by a modern residence hall that doesn't use these dangerous materials, and is part of the final phase of the University's overall upgrade to modern student housing. But before a new building can be built the old one must be removed.

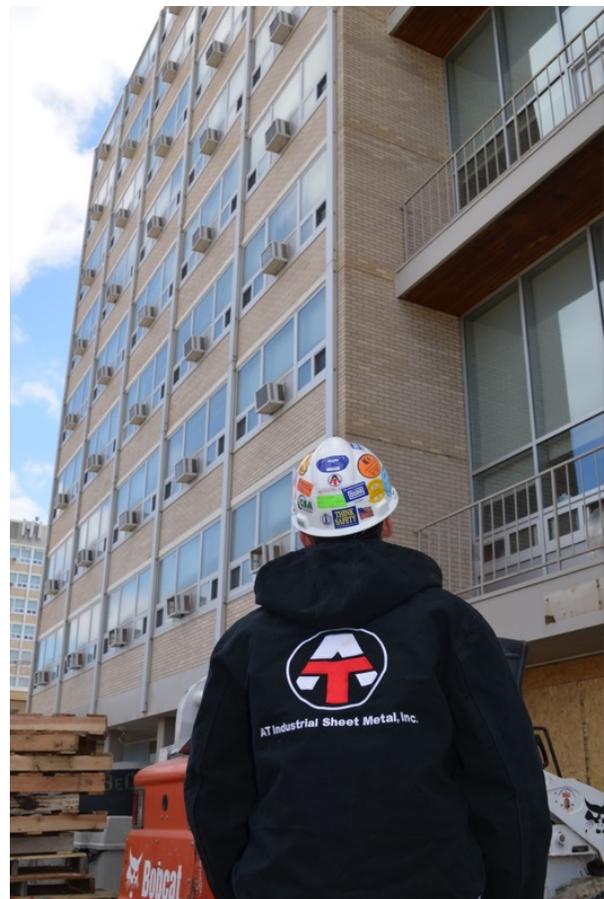
The Abatement Process

This process starts with sealing the building, in this particular case, two levels at a time. Using a plastic seal containment, all windows, exits and ventilation shafts are covered to stop any asbestos from escaping. Jones hall featured a common 60s era application for asbestos, using it in an adhesive to secure the tiling to the floor – reducing noise penetration and slowing any unexpected fires. It also unknowingly put students mere feet away from potentially cancer causing materials. AT Abatement's team of 13 carefully pulls these tiles up, wearing full personal protective equipment, and prepares them for disposal using a special mastic adhesive removal chemical that destroys asbestos. Even so, all debris is destroyed to prevent accidental exposure.

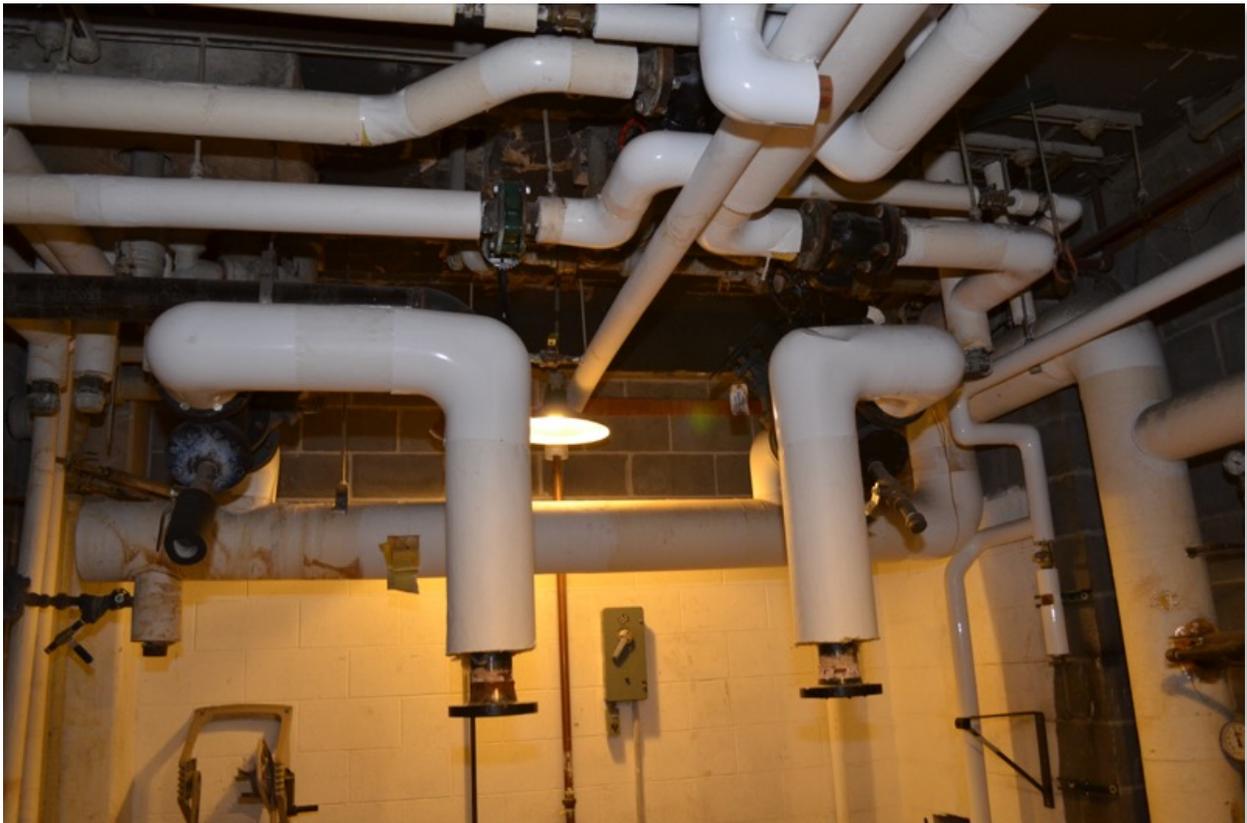
Of course, in buildings as old as Jones Hall, asbestos was used for a lot more than just coating floors and tiling, it was also used as insulation for piping (shown above), meaning that it can potentially be found anywhere and everywhere inside the walls. Making sure asbestos doesn't escape and create a serious environmental hazard requires a lot of internal demolition. AT checks every wall for signs of asbestos and

insulated pipe for signs of asbestos. Having a specialized abatement team makes this kind of demolition work possible, we prevent environmental disasters by doing it safely.

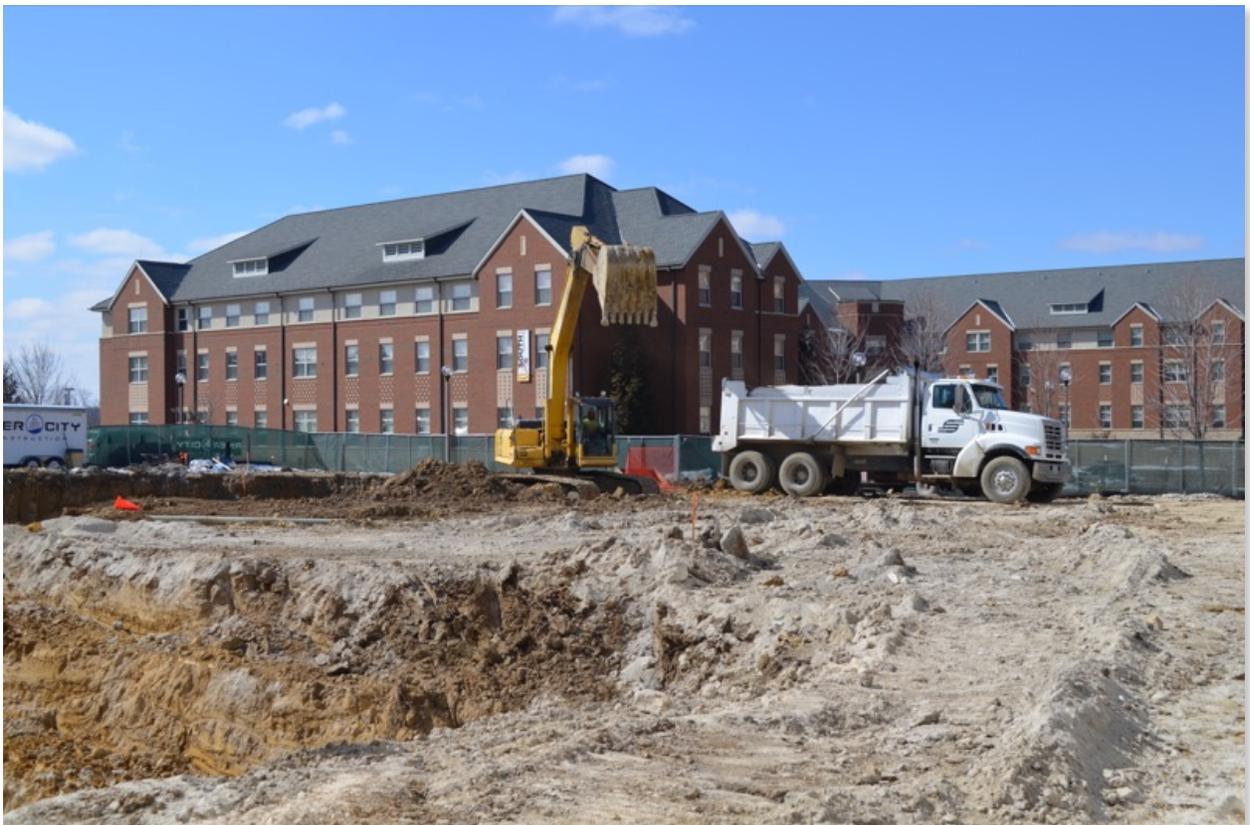
Jones Hall is located right near modernized student housing and directly across the street from a set of fraternity houses. While it would certainly more convenient to lace the hall with explosives and let it come crashing down on itself, it would be much less friendly to the habitability of the nearby residences. The only option for the demolition is deconstruction, from the top down.

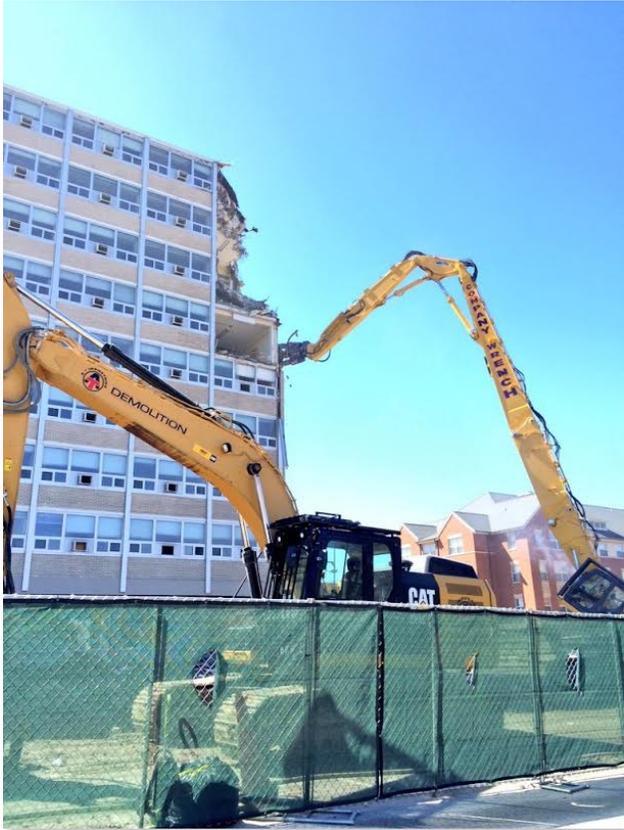
down process for this very reason. To complete the demolition, we have to use a high reach excavator that takes two to three days to set up. With it our teams can reach up to 190 feet above the ground where we will use the giant, shearing demolition processor on the end of its long arm to deconstruct the building piece by piece and floor by floor (pictured at left).

While the deconstruction process is underway, we also do everything possible to keep down the impact on the local community. Especially with a VA hospital, university hospital and residence halls in close proximity, it's extremely important that the dust is kept to minimal levels. Water canons are one important feature of every demolition that helps to keep the dust to a minimum. The high reach excavator is also equipped with a water nozzle that knocks the dust down before it reaches far into the air.
